CHERRY VALLEY FLOOD PLAIN MANAGEMENT STUDY

CROSS COUNTY, ARKANSAS

AUGUST 1986

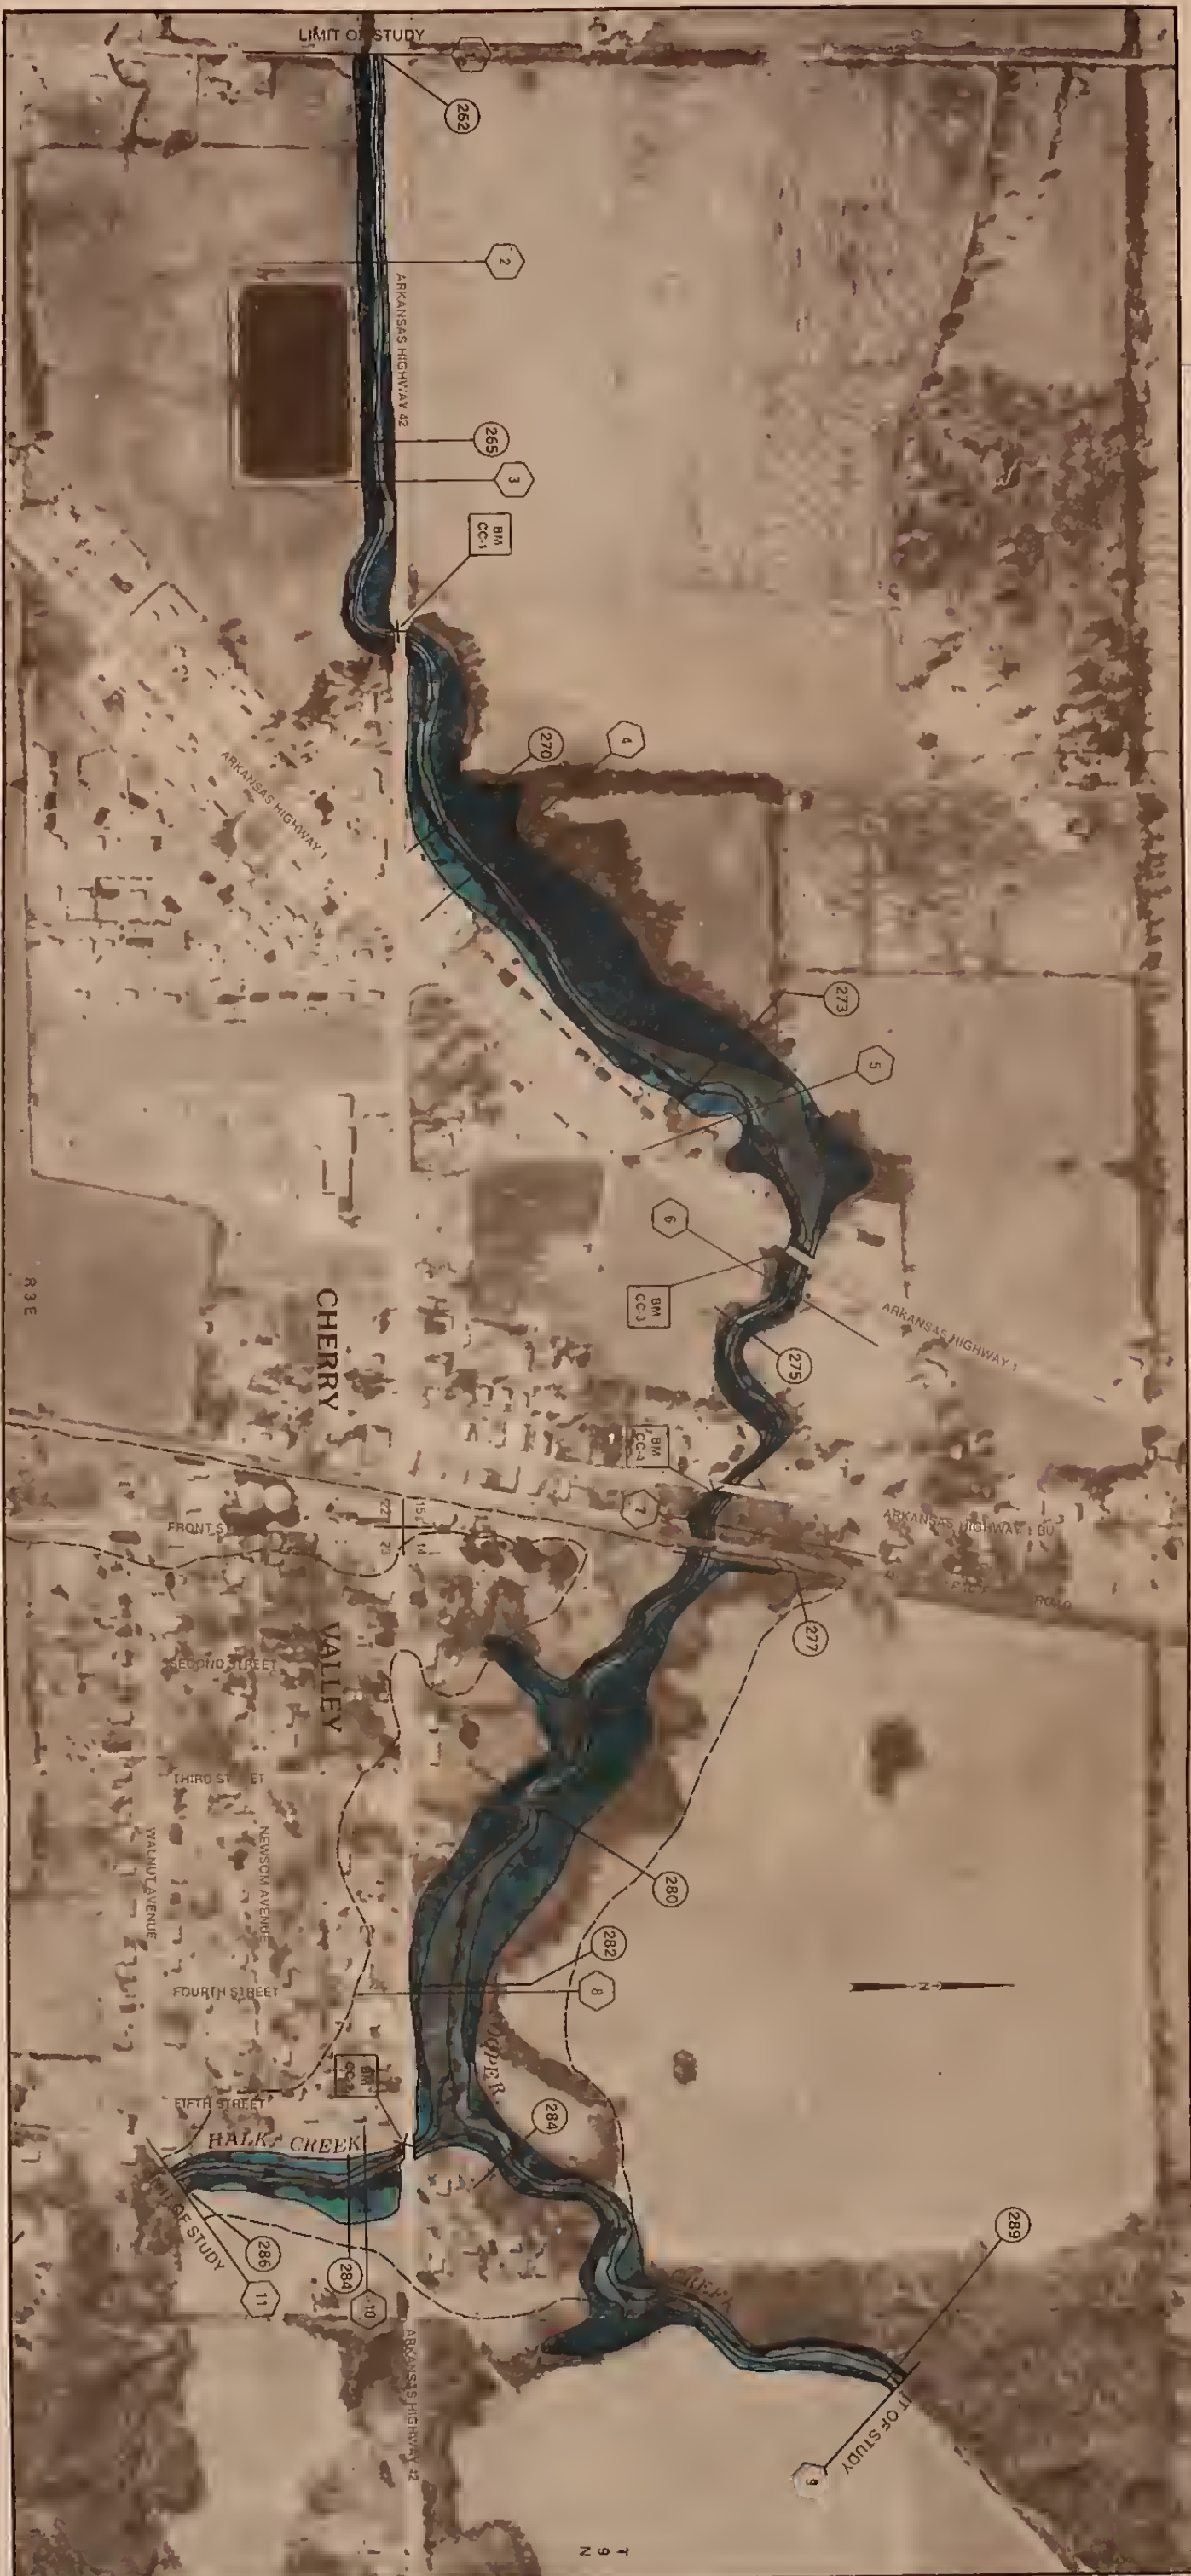
# FLOOD HAZARD AREA CHERRY VALLEY

U.S. DEPARTMENT OF AGRICULTURE  
SOIL CONSERVATION SERVICE  
CHERRY VALLEY  
FLOOD PLAIN MANAGEMENT STUDY  
CROSS COUNTY, ARKANSAS

While this extreme event produced damaging flooding in Cherry Valley, hydraulic and hydrologic investigations made during this study indicate that frequent flooding of the developed area should not be a major problem. The area inundated by the one- and ten-percent chance flood events is shown on the Flood Hazard Area Map. The channels in the study area are large and velocities are relatively high and out-of-bank flooding occurs only at a limited number of locations. Bridges and the railroad trestle on Cooper Creek are adequate if they do not become obstructed by debris during high flows. The 1 percent chance flood would inundate about 53 acres of undeveloped land in the study area. The 0.2 percent chance flood was not studied due to the absence of toxic chemical storage facilities, hospitals, or schools.

The width of the flood area was determined at each of the cross sections. This was done by using the elevation of the flood profile at that location and determining the point at which that elevation intersected the ground on the plotted cross section. The flood boundary between cross sections was delineated with the aid of topographic quadrangle maps and additional topographic surveys.
